A Permanent Metal CoatingTM That Resists Zebra Mussels

**By Lee Cook, Ed Devino,
Mike Sullivan, Bob Weed,
And Tim Masty**

November 30, 2000

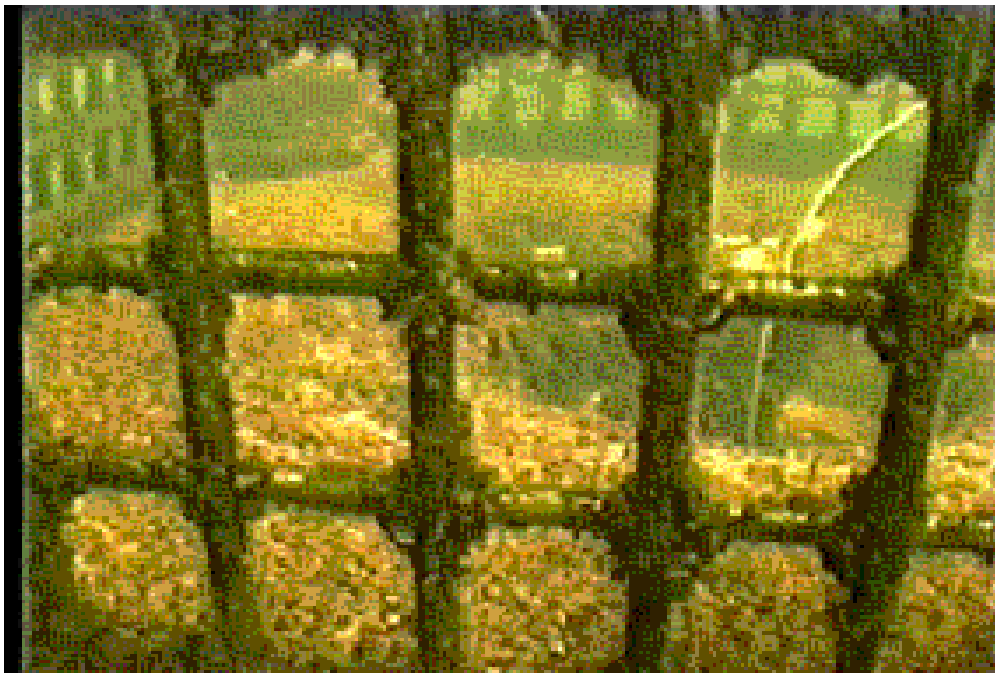
3.1.1 Image 1 - Zebra Mussels Attach At the Corners

Image-1 shows that in July the **Zebra Mussels** had begun to attach at the corners of the openings, but that, in general, the bars are clear of **Zebra Mussels**, and that flow through the grating does not seem to be significantly impaired.

The first set of images (1, 2, & 3) shows the “**uncoated stainless steel bar grating**” at the intake site. The sonic control device was in use at this location. The bar grating consists of **1/2"** diameter stainless steel bars welded together to create a **2" x 2"** grid with **1 1/2" x 1 1/2"** opening. All three images are of the same area of the grating.

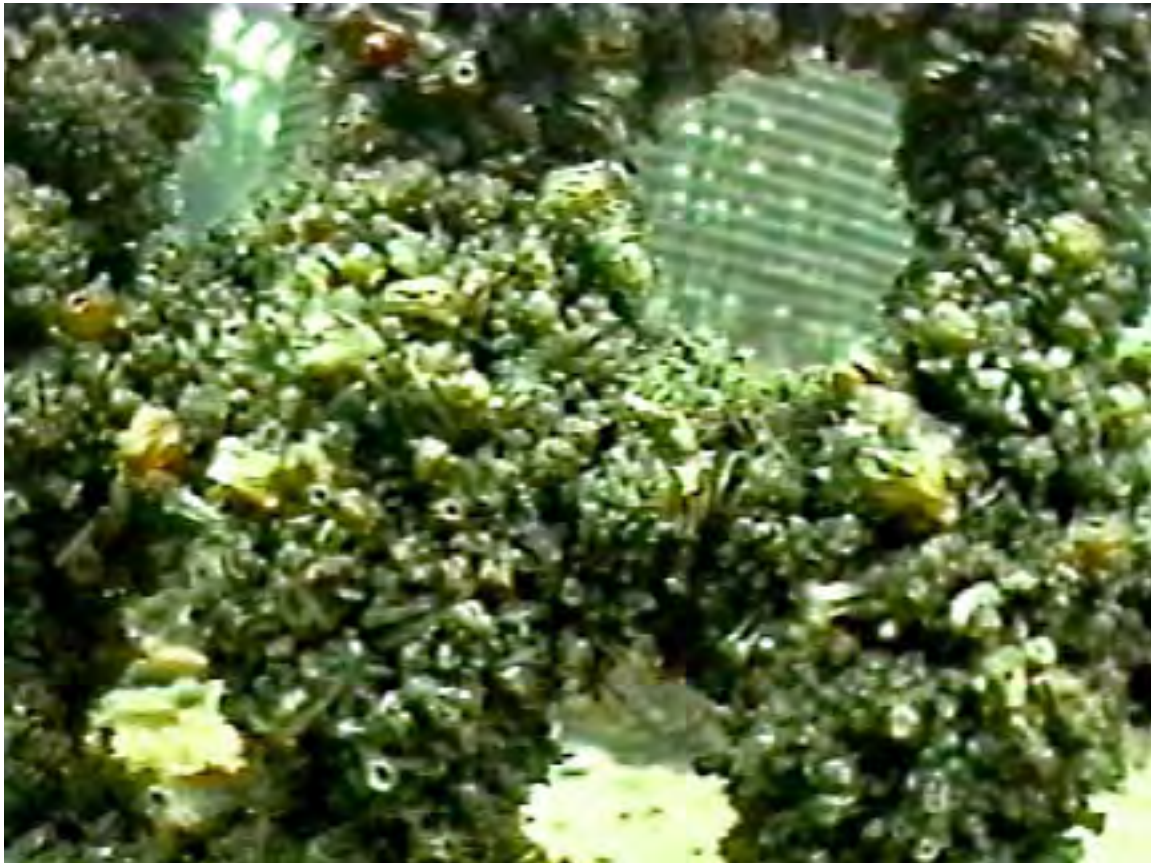
3.1.3 Image 3 - Build Up Of Zebra Mussels

Image-3 is a closer view of the same general area shown in **Image 2**, which was recorded less than 3 weeks later on October 27th. In this brief period, the build up of **Zebra Mussels** has increased dramatically and the available flow area of the grating has been reduced by more than **60%**.

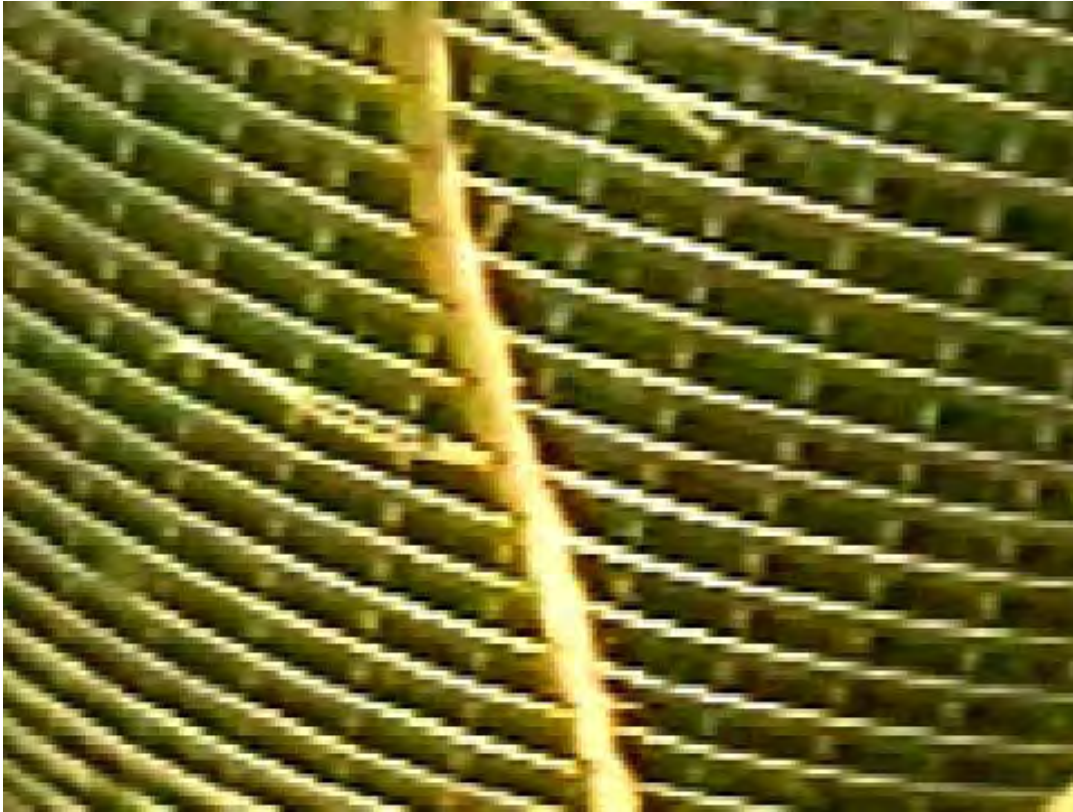
3.1.4 Image 4 - Zebra Mussel Attachment

Image-4, the screen is clear of all **Zebra Mussel** attachment. One adult **Zebra Mussel** was found on the screen during the inspection, but it was removed by the diver during the inspection.

The images in the second set (**4, 5, & 6**) show an “**uncoated stainless steel welded profile wire screen**” at the site where the **sonic control** device was in use. The screen was nominally **18"** in diameter and **36"** long with a **carbon steel flange** on one end and a **solid plate** at the other. The screen construction commonly used for water well screens of this diameter. The screen opening (**slot**) was $\frac{1}{4}$ " and the width of the triangular wire at its base (the outer surface) was about $\frac{5}{32}$ ". Initial open area at the screen surface was about **60%**. Unlike most “**welded profile wire screens**” used as intake screens, this screen had no internal flow balancing system to control maximum through screen velocity. [Such flow balancing systems are normally employed to minimize debris accumulation and impingement or entrainment of fish at the water intake.] Vendors of the **Sonic Zebra Mussel Control Device** have advised that their system seems to work better when an intake screen is mounted on the end of the intake pipe. The new intake screen was installed in Mid July of 1997.

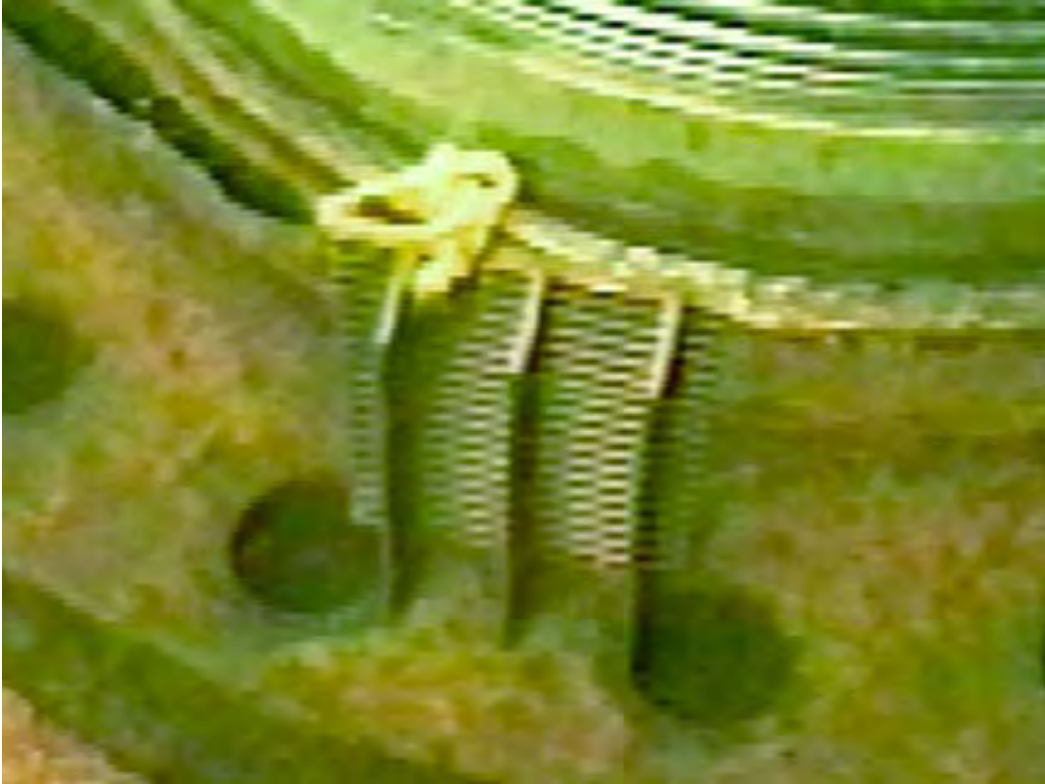
3.1.7 Image 7 - Zebra Mussels July Inspection

Image-7 shows the screen free of **Zebra Mussels** during the July inspection.

The third set of images (7, 8, & 9) also shows a welded, “**stainless steel profile wire screen**”. This screen section has been coated with **Jacquelyn™**, the selected test material. Coating thickness is in the range of **0.005"**. The screen is a section typical of screens commonly used for water intake screening applications. The screen opening size is nominally $\frac{1}{8}$ " prior to coating application. The wire face width (after coating) is nominally **0.080"**. The support bars are **14 ga.** (0.075") thick and **1"** deep on **1"** spacing. This screen section is approximately **3" x 3"**. This section of coated test screen was placed on the flange, which connected the screen in images 4, 5, & 6 over the intake pipe. A rope was connected to the screen to keep it at the test site.

This coated test screen was installed in mid July of 1997 along with the uncoated screen.

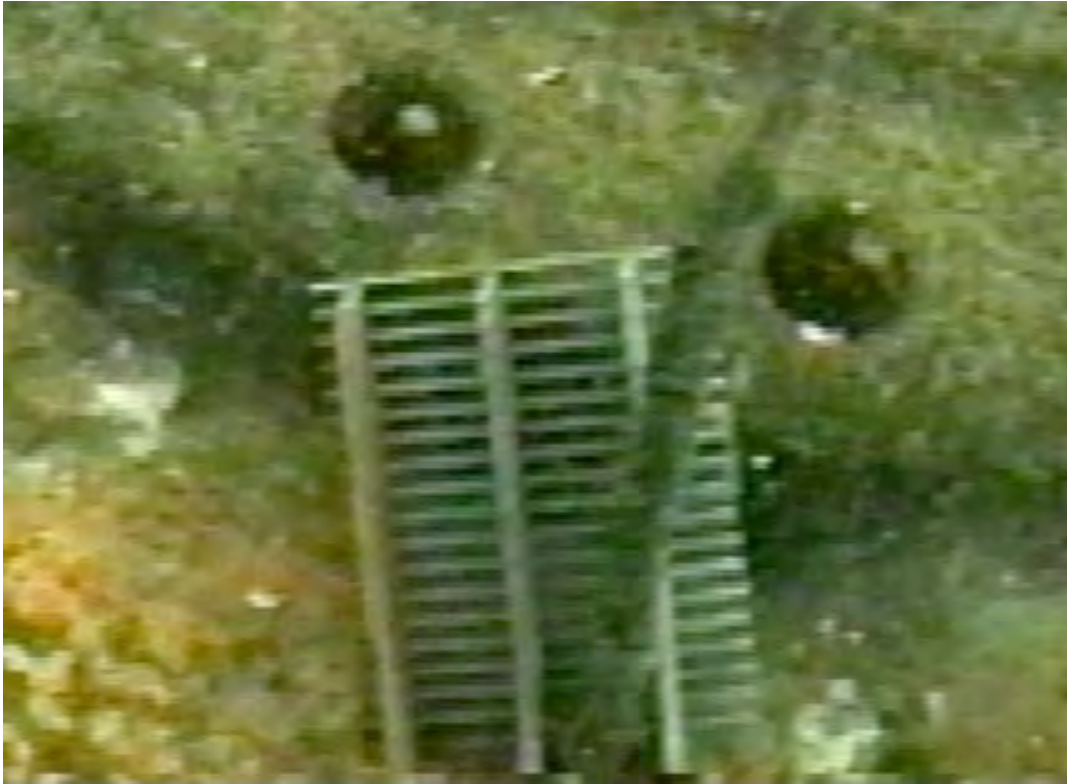
3.1.8 Image 8 - Slipped From Its Original Position

Image-8, recorded on October 7th, shows that the screen has slipped from its original position. Of much greater importance, it shows that the screen is still free of **Zebra Mussel** attachment including attachment by **Juvenile Zebra Mussels**.

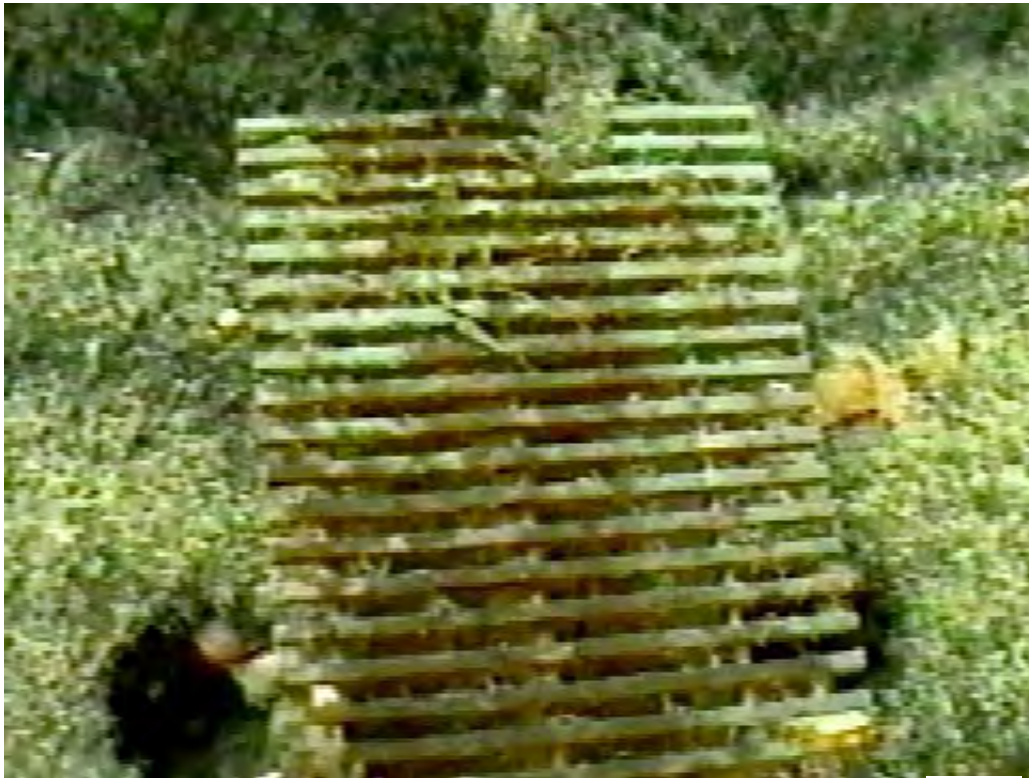
3.1.9 Image 9 - Free Of Zebra Mussel Attachment

Image-9, of the coated screen, section was recorded on October 27th. This image along with the diver's report of his observations shows the screen to continue to remain free of **Zebra Mussel** attachment. While the “**uncoated bar grating**” and the “**uncoated welded profile wire screen**” display **Zebra Mussel** attachment that would significantly obstruct the water flow path, there is no attachment on the coated test screen section at the same site.

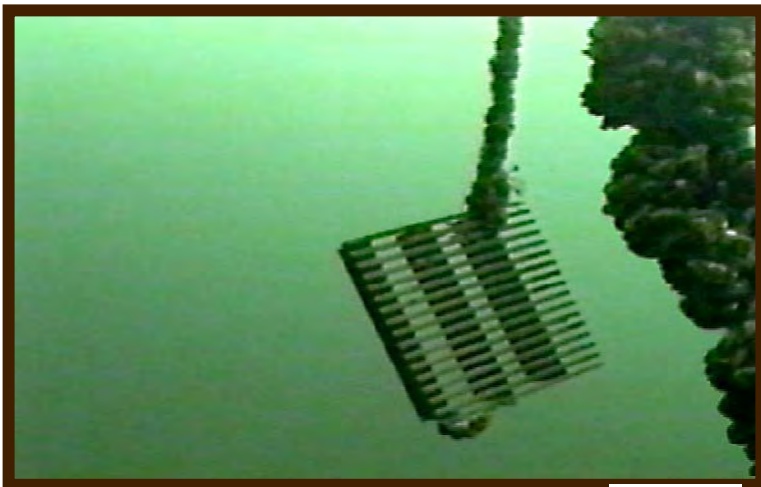
3.1.10 Images 10 & 11 - Coated Test Screen Section

Images 10 & 11, the final set, shows a coated test screen section identical in construction and approximately the same size as the screen in Images 7, 8, & 9. Unlike that screen, this screen section was located in the same general vicinity, but away from the impact of the **Sonic Control Device**. The screen in Images 10 and 11 was also installed in mid July of 1997. Image 10 was recorded on October 7th and image 11 was recorded on October 27th. It was suspended by rope from a marker buoy anchored to the lake bottom by a concrete weight. The buoy was connected to the weight by a heavy rope. (A portion of the rope can be seen in the upper right hand corner of Image 10. It is heavily covered with **Zebra Mussels**.)

There were no images of this test screen section was recorded during the July inspection. It is reasonable to conclude that such an image would not be noticeably different from the October 7th or October 27th images. There are no **Zebra Mussels** on the coated screen surface.

Of additional interest in images 10 & 11 are the one adult **Zebra Mussel** that can be observed at the lower left corner of the test screen. The process of test screen section preparation involved application of the coating to larger sections of screen -- approximately **18"** long and **3"** wide. These sections were cut after coating so that the ends of the support bars and a portion of the side of the surface wire were free of coating. The adult **Zebra Mussel** has attached to one of these uncoated areas. This suggests that while the coating resists the attachment of **Zebra Mussels** it does not repel the mussels.
